## **General Data Notes**

## Flight Specific Data Notes

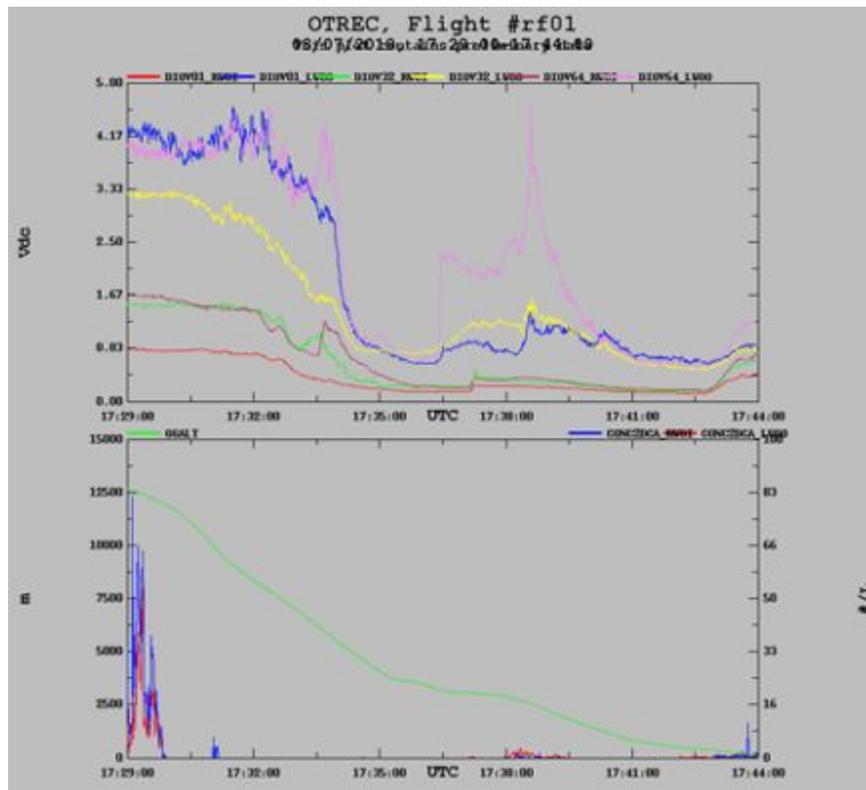
We present the example of OTREC RF01, last part of flight during a descent to land. The GV had been at high altitude for about 5 hours, so the 2D probes were thoroughly cold soaked. On descend, the diode voltages for both the 25-micron probe (LWOI) and the 10-micron probe (RWOI) decreased dramatically, see Fig. A1.

Both 2D probes show a decrease in the recorded diode intensity from about 17:32:15 or earlier. The 25-micron probe (LWOO) has a particular strong decrease at about 17:34:00, and this decrease is likely due to condensation (dew or ice) on the optics.

Both probes appear to recover the diode voltages somewhat at 17:42:40, but this recovery is insufficient.

Figure A1. Time series from OTREC RF01. Upper box shows diode voltages for the 25-micron probe (LWOO) (generally large values), and from the 10-micron probe (RWOI) (generally smaller voltages). Bottom box shows altitude and concentrations of all particles from the two probes.

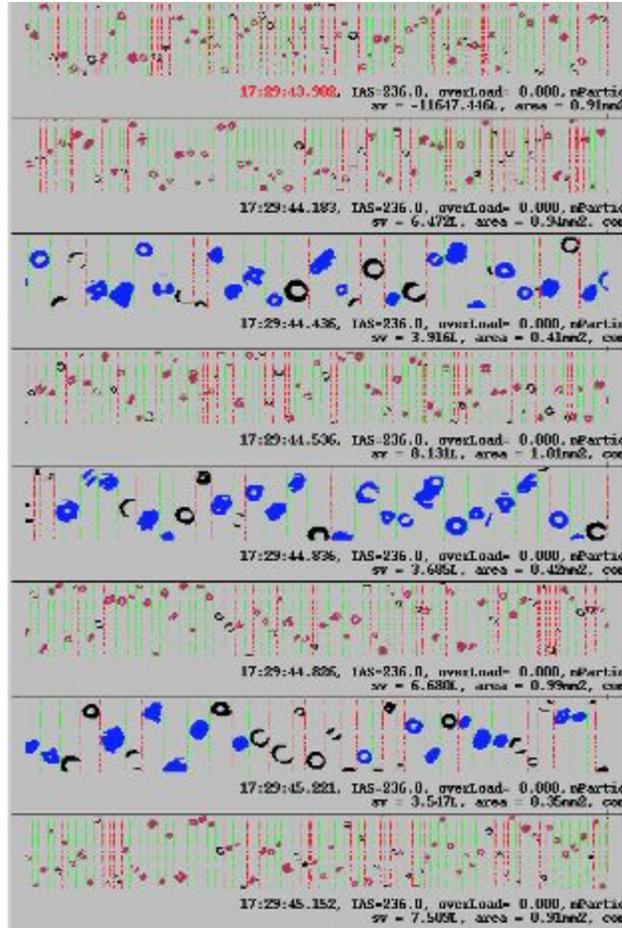
Figures A2, A3 and A4 show examples of 2D images from three time periods. The first one (A2) was collected in a wholly glaciated cloud (many irregular ice particles), where the images do not show any evidence of condensation on the probe optics. In contrast, figures A3 and A4 should show round raindrops, but they have many missing horizontal stripes and ragged particle edges; This is likely due to condensation on the probe optics.

Figure A2. Particle images from 17:29:44. Red particles are from the 25-micron probe (LWOO), and blue particles are from the 10-micron probe (RWOI). These particle images are considered good. The blue particles are collected from a 640-micron wide section, and the red images are collected from a 1600 micron wide section.

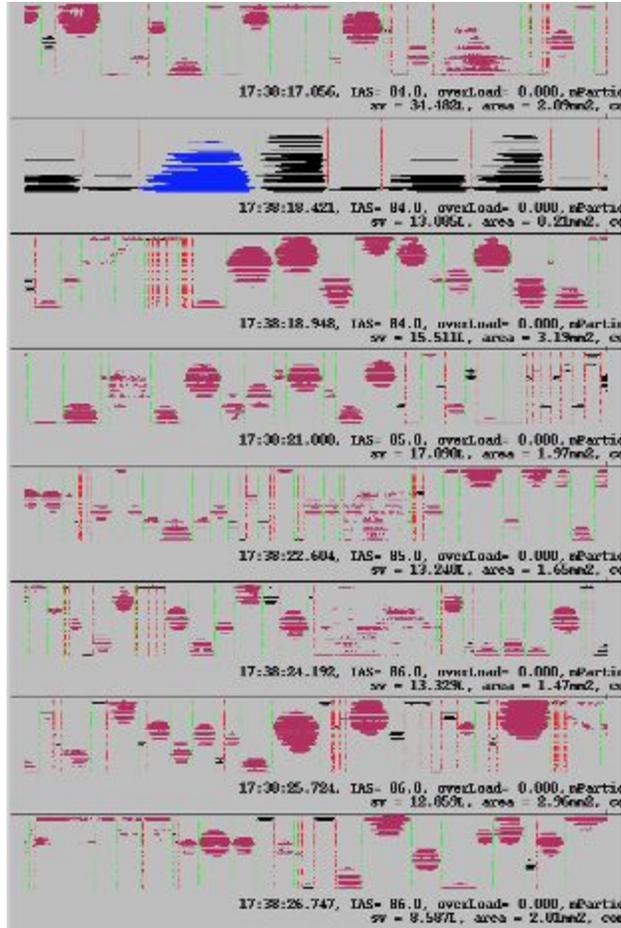
Figure A3. Particle images from 17:38:20. Red particles are from the 25-micron probe (LWOO), and blue particles are from the 10-micron probe (RWOI). These particle images should show solid round raindrops; instead the images have missing horizontal stripes and ragged edges where diodes are not triggering (likely due to condensation). These images are considered bad, and they should not be used for analysis.

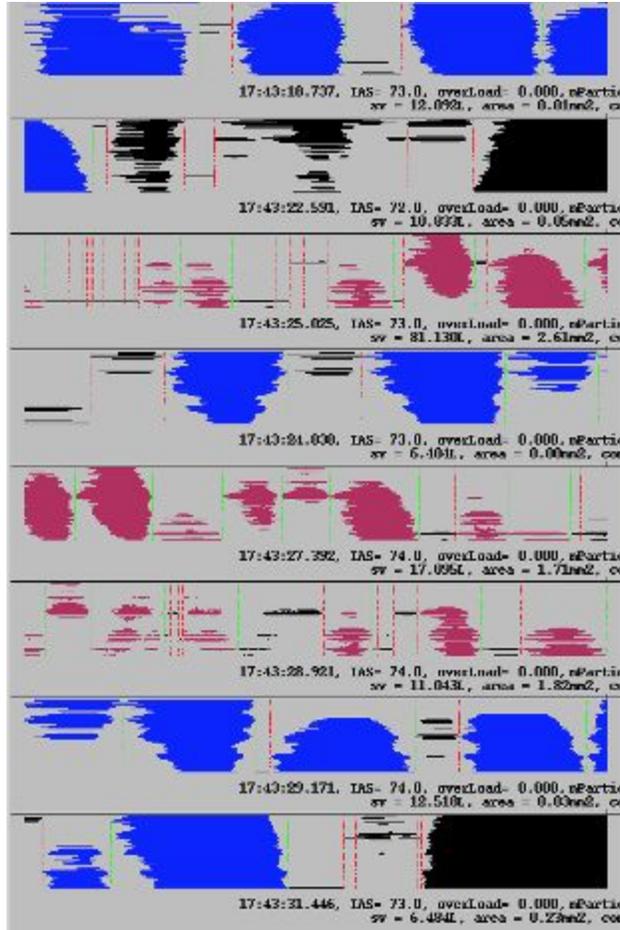
Figure A4. Particle images from 17:43:25. Red particles are from the 25-micron probe (LWOO), and blue particles are from the 10-micron probe (RWOI). These particle images should show solid round raindrops; instead the images have missing horizontal stripes and ragged edges where diodes are not triggering (likely due to condensation). These images are considered bad, and they should not be used for analysis.
