HAIC-HIWC Science Meeting 9-12 November 2015 BoM, Melbourne, Australia

Cayenne 2015 – Overview & SAFIRE F20 and HWL
B757 Achievements

HAIC/HIWC International Field Campaign

High Altitude Ice Crystals (HAIC, 314314)

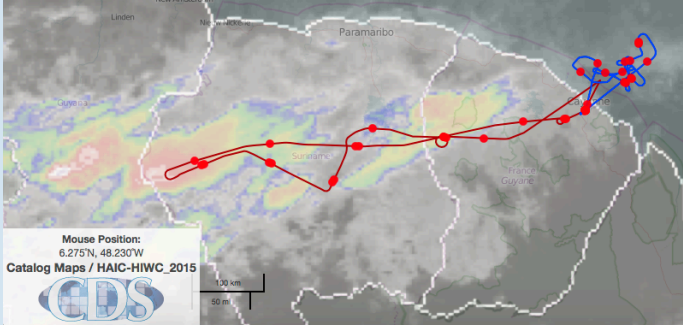
Flight	Observations	
<p data-bbox="112 344 355 386">12/05/2015</p> <p data-bbox="54 454 413 548">F20: FS15011, 2,5 F/H, 20:20 – 22:27</p> <p data-bbox="46 605 417 696">CV580: F8, 2,4F/H, 19:17 – 21:26 UTC</p>	<p data-bbox="465 291 1093 448">Dissociated flights: CV580 in oceanic clouds and F20 in continental convection</p> <p data-bbox="465 519 803 568">Light conditions</p>

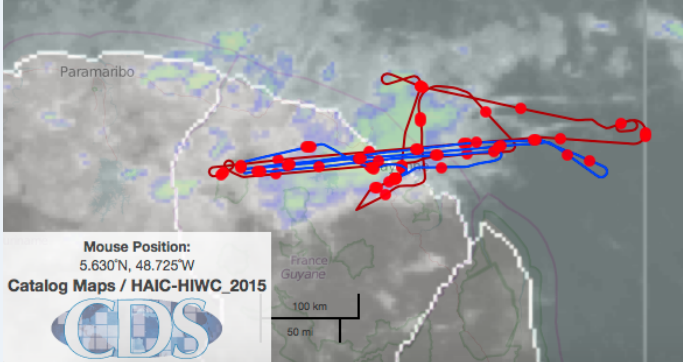
<p data-bbox="112 891 355 933">14/05/2015</p> <p data-bbox="54 1001 413 1143">F20: FS15012, 3,1 F/H, 14:17 – 17:15 UTC</p> <p data-bbox="46 1200 417 1292">CV580: F9, 3,7 F/H, 13:31 – 16:58 UTC</p>	<p data-bbox="465 838 890 886">Oceanic convection</p> <p data-bbox="465 952 1112 1166">Scientific coordinated flight for radar intercomparison. 3 legs were performed, low IWC < 1.0g/m³</p>

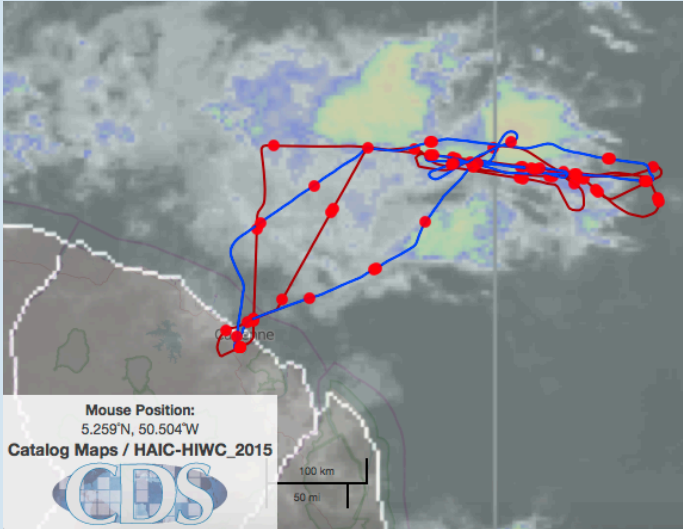
Flight	Observations	
<p>15/05/2015</p> <p>F20: FS15013, 3,7 F/H, 08:35 – 12:10UTC</p> <p>CV580: F10, 4,2 F/H, 08:56 – 12:57 UTC</p>	<p>Regulatory flight within Oceanic convection</p> <p>F20: FL -10°C to FL -45°C, IWC 3g/m³ peak and 2,0-2,5g/m³ sustained</p> <p>CV580: FL -5°C to FL -15°C, IWC ~1,0-1,5g/m³, IKP down for repair</p>

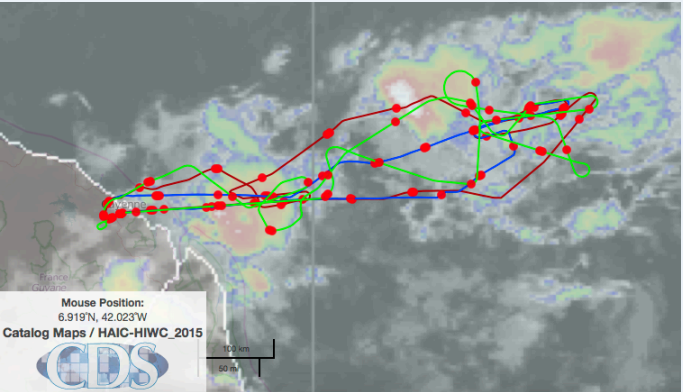
<p>16/05/2015</p> <p>F20: FS15014, 3,6 F/H</p> <p>CV580: F11, 3,9 F/H</p> <p>B757: F09, 3,7 F/H</p>	<p>First flight with the 3 A/C, Oceanic convection</p> <p>F20: FL -10°C to FL -30°C, IWC 3g/m³ peak and 2,0-2,5g/m³ sustained</p> <p>CV580: FL -5°C to FL -15°C, IWC ~3g/m³ peak</p>

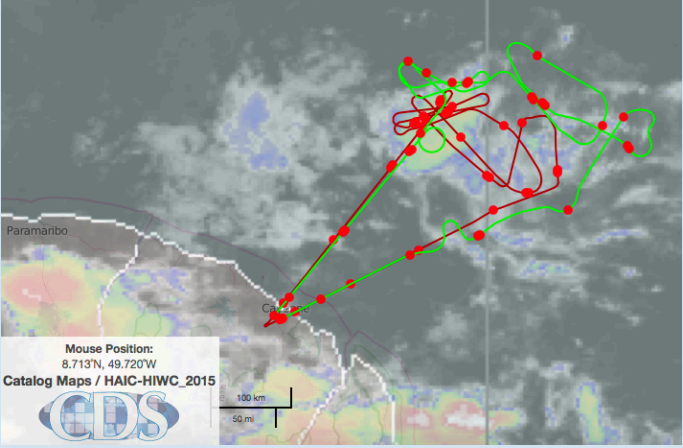
Flight	Observations	
<p data-bbox="112 396 357 444">18/05/2015</p> <p data-bbox="54 511 415 601">F20: FS15016, 3,3 F/H</p> <p data-bbox="54 658 415 705">B757: F10, 3,4 F/H</p>	<p data-bbox="465 294 842 332">Oceanic convection</p> <p data-bbox="465 394 1122 586">F20: 4 legs at FL -30°C, IWC 2.5g/m³ ; 4 legs at FL -45°C, IWC 1g/m³ ; 2 legs at FL -10°C, IWC 1.5g/m³</p> <p data-bbox="465 644 1074 691">2nd Robust installed on fuselage</p>

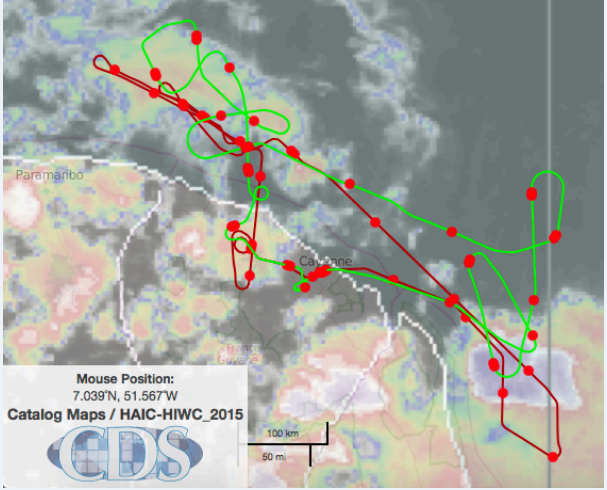
<p data-bbox="1203 658 1421 765"> Mouse Position: 8.713°N, 49.720°W Catalog Maps / HAIC-HIWC_2015 CDS 100 km / 50 mi </p>
<p data-bbox="112 943 357 991">19/05/2015</p> <p data-bbox="54 1058 415 1148">F20: FS15017, 3,4 F/H</p> <p data-bbox="54 1205 415 1252">B757: F11, 3,5 F/H</p>	<p data-bbox="465 841 871 879">Oceanic convection</p> <p data-bbox="465 936 1089 1033">Brazil military commanded the A/C to leave the airspace</p> <p data-bbox="465 1090 1078 1286">F20: FL -30°C and -45°C ; IWC 1.5-2.0g/m³, lightning diverter strips on the radome needs to be replaced</p>

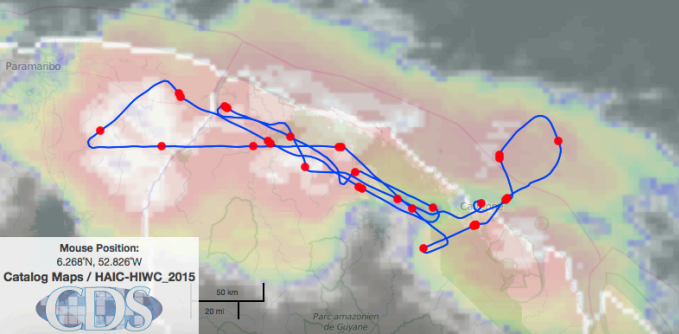
Flight	Observations	
<p data-bbox="112 448 355 491">20/05/2015</p> <p data-bbox="50 561 417 648">CV580: F13, 3,5 F/ H</p>	<p data-bbox="465 291 1058 334">Oceanic/continental convection</p> <p data-bbox="465 391 1108 491">4 legs performed at FL -10°C with TWC 3-4g/m3</p>

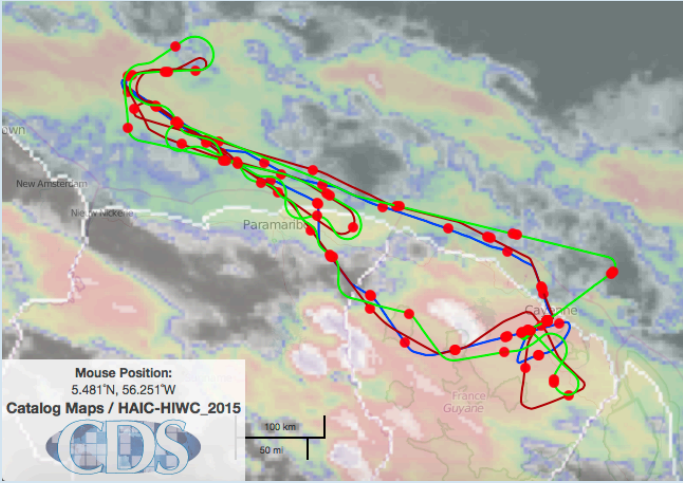
Flight	Observations	
<p>23/05/2015</p> <p>F20: FS15019, 3,8 F/H</p> <p>CV580: F15, 3,8 F/H</p> <p>B757: F13, 3,8 F/H</p>	<p>Oceanic/continental convection</p> <p>F20: FL 200 (-10°C) to FL 360 (-45°C) ; ~5 legs performed ; IWC 3g/m³ peak with 2g/m³ sustained over more than 20NM at FL200 (-10°C), peak IWC 2g/m³ at FL360 (-45°C)</p> <p>CV580: , FL -5°C to FL -15°C</p>

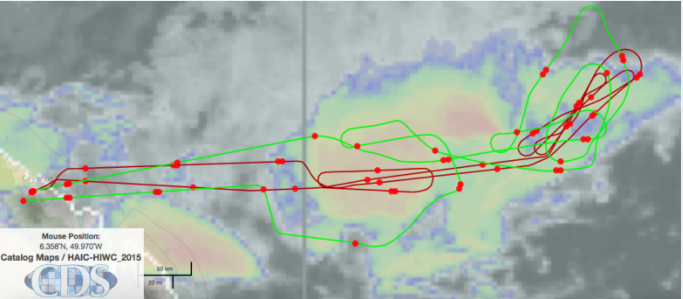
<p>24/05/2015</p> <p>F20: FS15020, 3,5 F/H</p> <p>B757: F14, 3,5 F/H</p>	<p>Oceanic convection, complementary objective to collect data for the WXR at intermediate FL from -30°C to -45°C</p> <p>F20: FL 300 (~-30°C) to FL 360 (~-45°C) ; ~10 legs performed, IWC 4g/m³ peak, sustained IWC 1,0-1,5g/m³ over 20NM ; small cells <50NM</p>

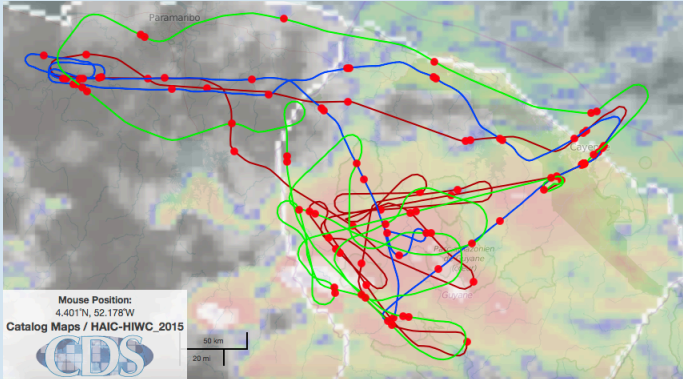
Flight	Observations	
<p>25/05/2015</p> <p>F20: FS15021, 3,7 F/H</p> <p>CV580: F16, 3,9 F/ H</p> <p>B757: F15, 3,8 F/H</p>	<p>Continental convection</p> <p>F20: FL300 (-30°C) to FL360 (-45°C) ; IWC 4g/m³ peak and some 3g/m³ sustained at FL360 (-45°C) , LWC probe installed, lightning diverter strips on the radome needs to be replaced</p> <p>CV580: FL 200 (-10°C), IWC > 2.0g/m³</p>

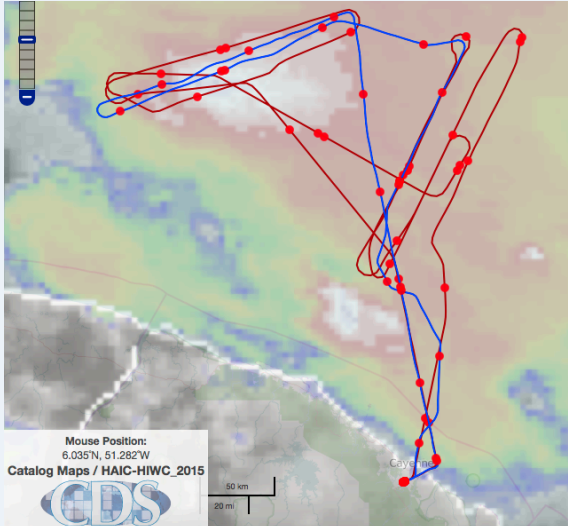
<p>26/05/2015</p> <p>F20: FS15022, 3,5 F/H</p> <p>CV580: F17, 3,1 F/ H</p>	<p>Oceanic convection</p> <p>F20: FL210 (-10°C) to FL360 (-45°C) ; 2 legs at FL210, 1 leg at FL300, 5 legs at FL360 ; IWC 5g/m³ peak and some 3g/m³ sustained</p> <p>CV580: FL 200 (-10°C), IWC > 3.0g/m³</p>

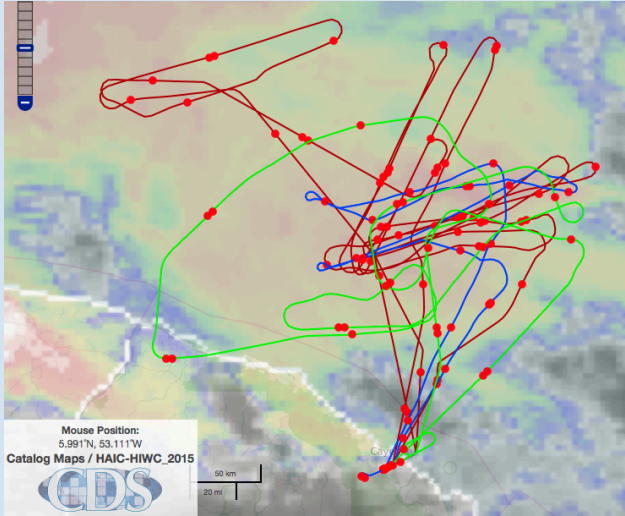
Flight	Observations	
<p>26/05/2015</p> <p>F20: FS15023, 2,8 F/H</p> <p>CV580: F18, 3,0 F/H</p> <p>B757: F16, 3,0 F/H</p>	<p>Oceanic convection, Quick turn around</p> <p>F20: FL210 (-10°C) to FL360 (-45°C) ; 4 legs at FL210, 3 legs at FL360 ; IWC 3g/m3 peak and some 1.0-2.0g/m3 sustained at FL210, IWC 0.5-1.5g/m3 at FL360</p> <p>CV580: FL 200 (-10°C), IWC > 2.0g/m3 sustained</p>

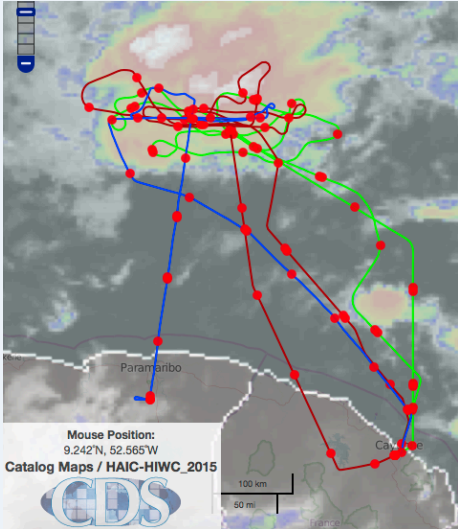
<p>Map showing flight paths (red, green, blue lines) over a region. Mouse Position: 5.991°N, 53.111°W. Catalog Maps / HAIC-HIWC_2015. Scale: 50 km, 20 mi.</p>
<p>27/05/2015</p> <p>F20: FS14024, 3,9 F/H</p> <p>CV580: F19, 4,0 F/H</p> <p>B757: F17, 3,5 F/H</p>	<p>Oceanic convection, System with very short life cycle leading to very difficult coordination</p> <p>F20: FL300 (-30°C, conditions not good enough to climb to FL360) ; IWC 2g/m3 peak and some 2g/m3 sustained at FL300 (-30°C)</p> <p>CV580: , FL 200 (-10°C), IWC > 2.0-3.0g/m3, last flight</p>

<p>Map showing flight paths (red, green, blue lines) over a region. Mouse Position: 9.242°N, 52.565°W. Catalog Maps / HAIC-HIWC_2015. Scale: 100 km, 50 mi.</p>

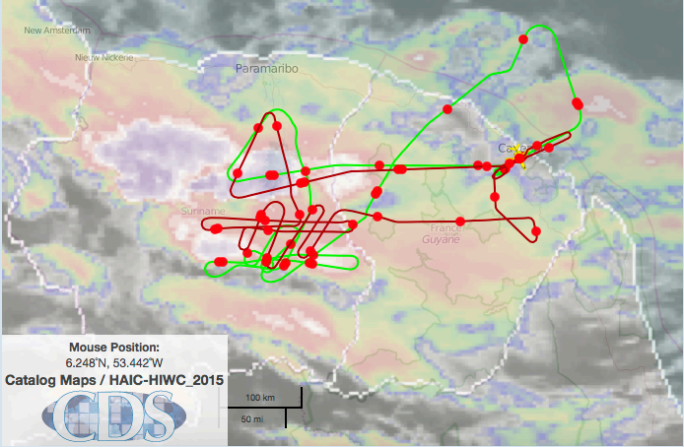
Flight	Observations	
<p>28/05/2015</p> <p>F20: FS15025, 3,7 F/H</p> <p>B757: F18, 3,5 F/H</p>	<p>Continental convection, Cloud top at 16km+. Surprisingly, quite low IWC: IWCmax ~2g/m³ at FL300 (-30°C) and IWCmax ~1g/m³ at FL360 (-45°C)</p> <p>F20: FL300 (-30°C) to FL360 (-45°C) ; 13 legs performed ; IWC 2g/m³ peak and some 1.0g/m³ sustained</p>

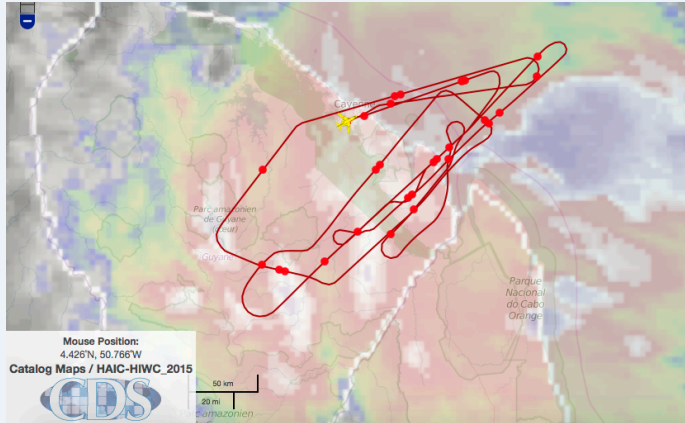
<p>29/05/2015</p> <p>F20: FS14026, 3,5 F/H</p>	<p>Oceanic/continental convection</p> <p>F20: FL210 (-10°C) to FL360 (-45°C) ; 10 legs performed ; IWC 2.5g/m³ peak and some 1.0-1.5g/m³ sustained</p> <p>Last flight!</p>
