CONTRAST Project Manager Report

CONTRAST GV payload

11/22/2013

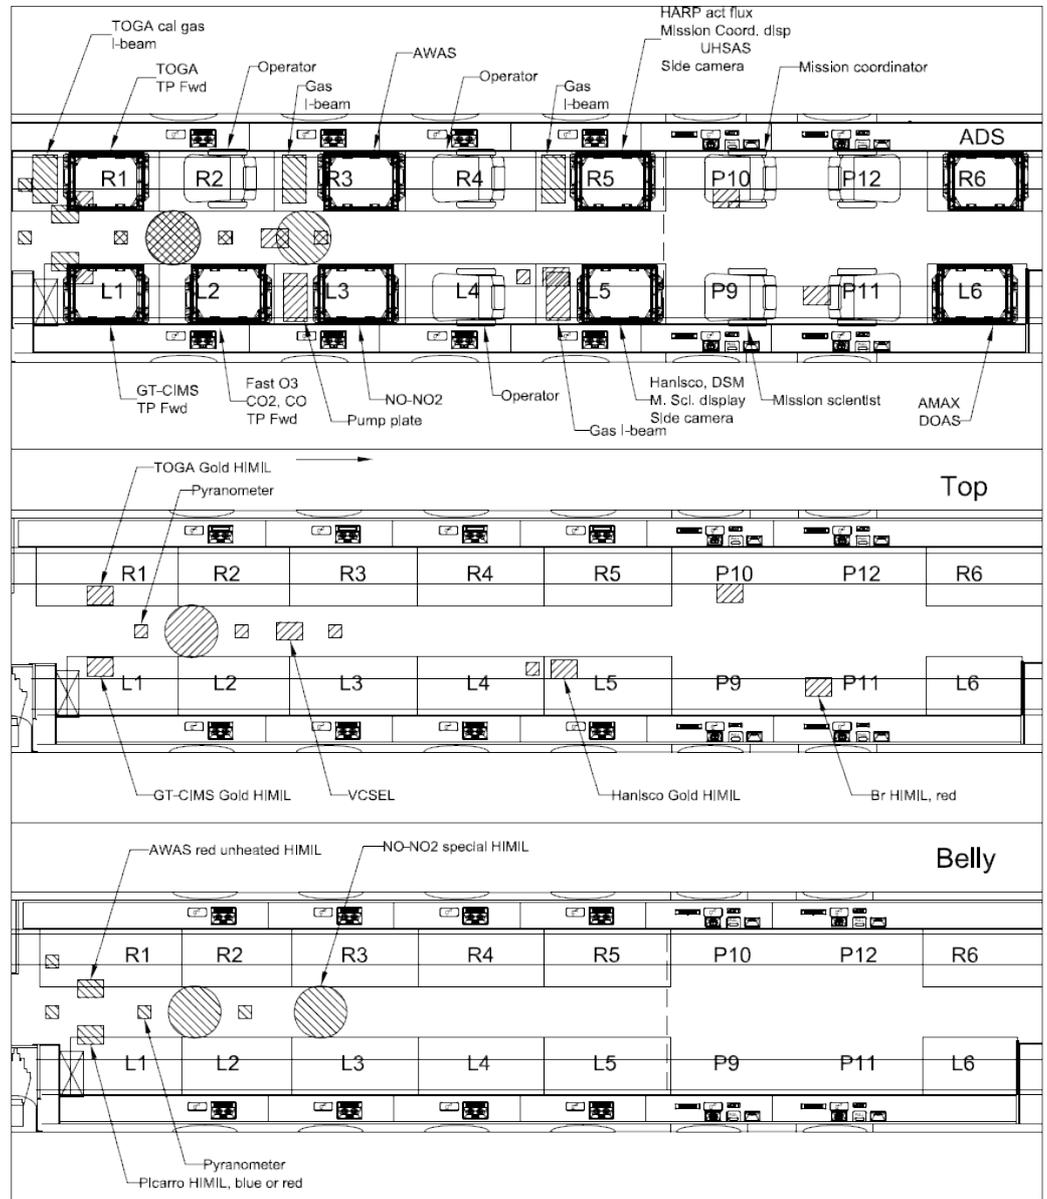
Aircraft payload

- VCSEL
- Fast O3
- NO-NO2
- VUV CO
- Picarro CO2, CH4
- CH2O
- GT-CIMS
- AMAX-DOAS
- Br (BRIGHT)
- AWAS
- TOGA
- UHSAS
- 2D-C
- CDP
- HARP
- Mission coord.
- Mission sci.
- Gas cylinder rack
- Gas I-beam, x4
